# TERAFLEX

## Technical Service Bulletin JK HD Ball Joint Kit 2013+ JK Stub Shaft Modification

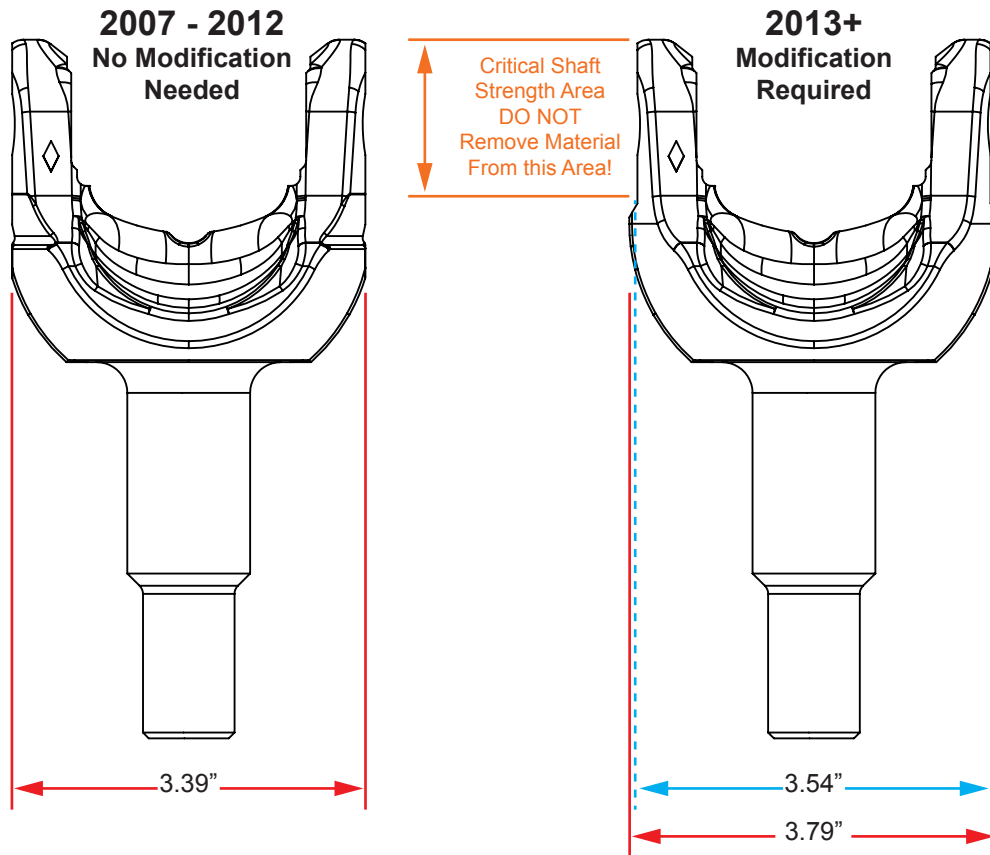
2013 and newer front Dana 30 & Dana 44 equipped JK Wranglers utilize a larger diameter outer stub shaft. This causes interference issues when used with TeraFlex HD Ball Joints (lower ball joint only).

Note: By avoiding any modification to the critical strength area, shown above, the outer stub shaft's performance and strength will not be affected by this slight modification.

A DIY solution to fix this issue involves minor clearing of a non-critical area of the outer stub shaft to allow proper lower ball joint clearance. As seen in the diagram above, removal of approximately 0.125" from each side of the outside diameter of the outer stub shaft shoulder is required.
